# Save Lives...work together to implement the Five Advisories at the ballast level

2011 SOFA Report, Vol. 1 and 2

## Switching Fatality and Severe Injury Update – 2011 Second Quarter, Advisory Edition

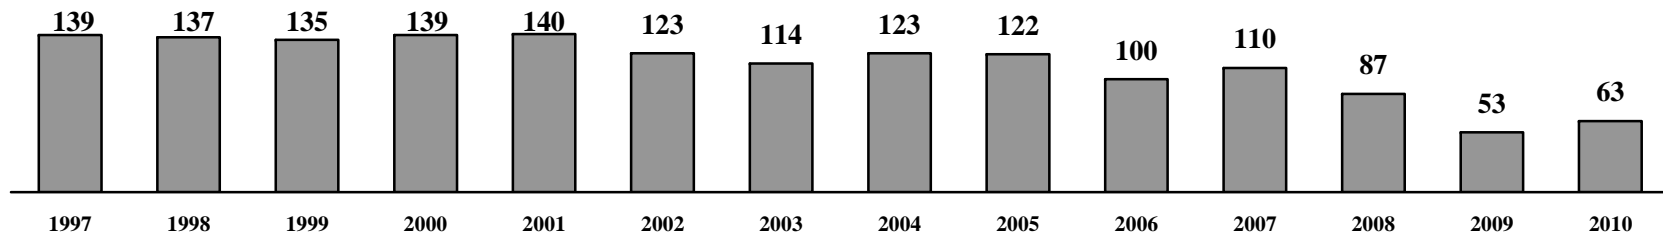
**SOFA-defined Severe Injuries by year, 1997 through 2010**  
(1997 is the first year these injuries can be defined based on the interests of SWG)

**Definition:** Based on its interests, *Severe Injuries* are defined by the SOFA Working Group as (1) potentially life threatening; (2) having a high likelihood of permanent loss of function, permanent occupational limitation, or other permanent disability; (3) likely to result in significant work restrictions; and (4) resulting from a high-energy impact to the human body. ‘Severe Injuries’ include amputation, dislocation of the neck, loss of eye, electric shock or burn, and fracture to any bone except the lower arm, fingers, foot, and toes. 1997 is the first year these Injuries to train and engine service employees can be determined as defined by the interest of the SOFA Working Group. For more information, see *Severe Injuries to Train and Engine Service Employees: Data Description and Injury Characteristics*. July 2001. <http://www.fra.dot.gov/Pages/1781.shtml>
